**To:** Myers, Craig[Myers.Craig@epa.gov]  
**Cc:** Wall, Dan[wall.dan@epa.gov]; Hermann, Karl[Hermann.Karl@epa.gov]; Pierce, Maggie[Pierce.Maggie@epa.gov]; Laidlaw, Tina[Laidlaw.Tina@epa.gov]; McComb, Martin[McComb.Martin@epa.gov]  
**From:** Spence, Sandra  
**Sent:** Tue 8/18/2015 11:43:55 PM  
**Subject:** Cement Creek/Animas Color

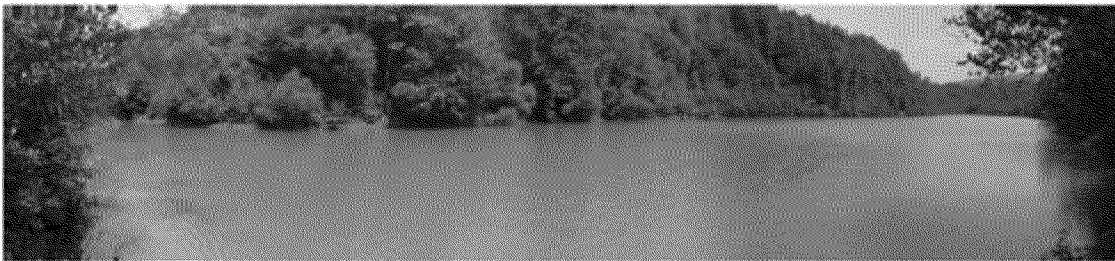
An algal bloom in a pond? Nope. The Excelsior Strip Pit discharge to the Shamokin Creek not far from Shamokin, PA. It changes green to a reddish orange, depending on the condition of the mine pool and how much oxygen is available to change the color of aluminum. Just recently the SCRA (<http://www.shamokincreek.org/>) installed a weir to measure the flow.

Note the photo below and caption below it. This photo and caption are from a document entitled, "Easter Pennsylvania Coalition for Abandoned Mine Reclamation." Maybe the color will look familiar to you – it's due to iron/aluminum.
